NL INDUSTRIES/TARACORP SUPERFUND SITE GROUP
Leed Environmental, Inc.
Van Reed Office Plaza
2209 Quarry Drive, Suite C-35
Reading, PA 19609
Telephone: (610) 670-7310
Facsimile: (610) 670-7311

Re: NL Industries/Taracorp Superfund Site; Granite City, Illinois
First 2020 Semi-Annual Operation and Maintenance Inspection (June 2020)

**NL Industries/Taracorp Superfund Site
Inspection Log - Operation and Maintenance**

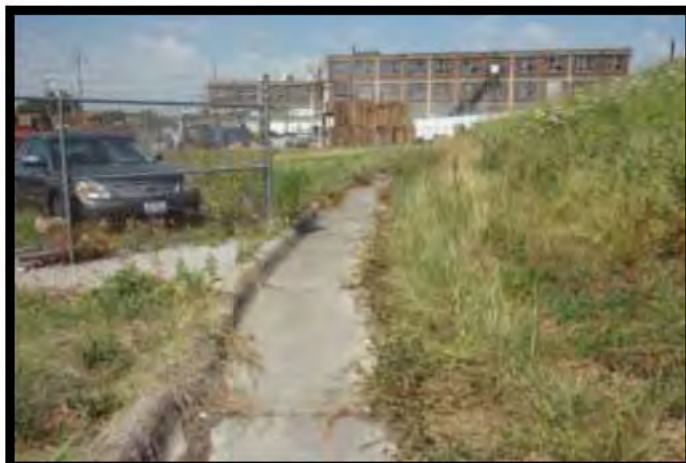
Photograph 49: Concrete drainage swale along southern slope of Taracorp pile.

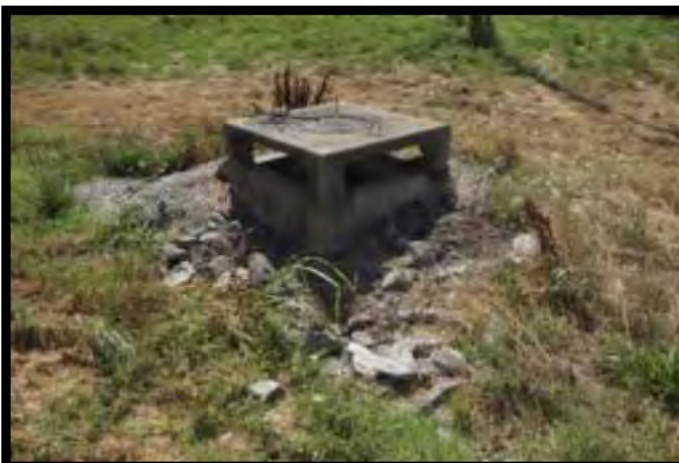
Photograph 50: Southern side of Taracorp pile, stormwater outlet.

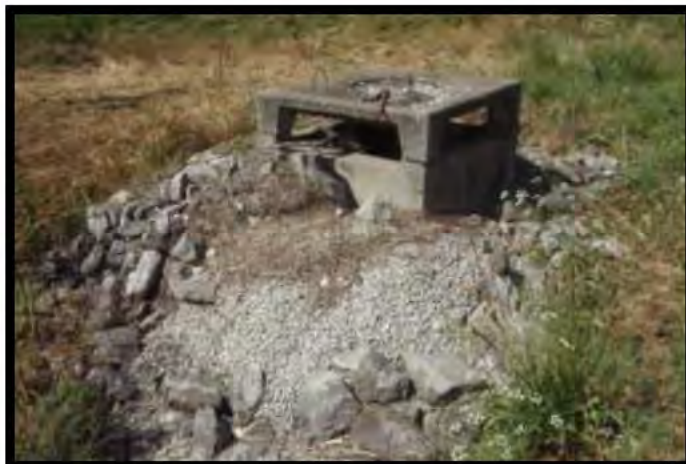
Photograph 51: Stormwater outlet.

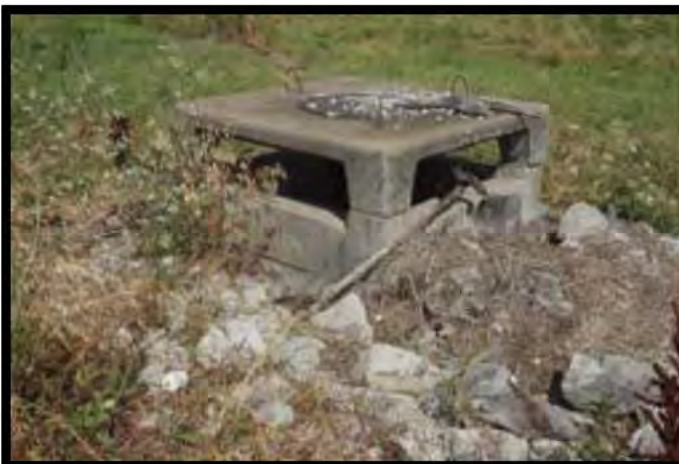
Photograph 52: Stormwater outlet.

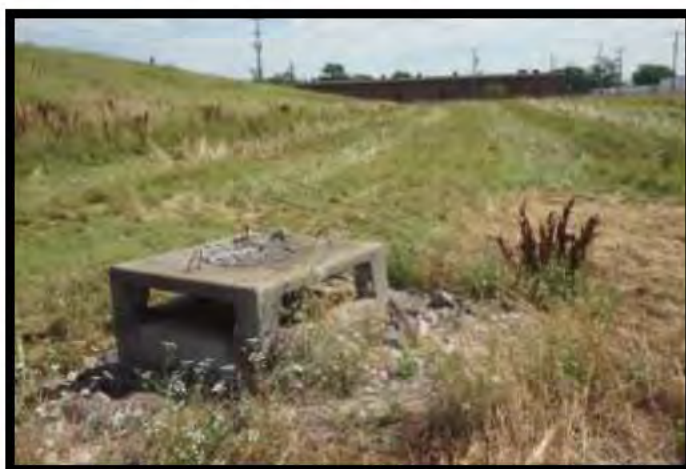
Photograph 53: Stormwater outlet and stormwater retention basin (view northeast).

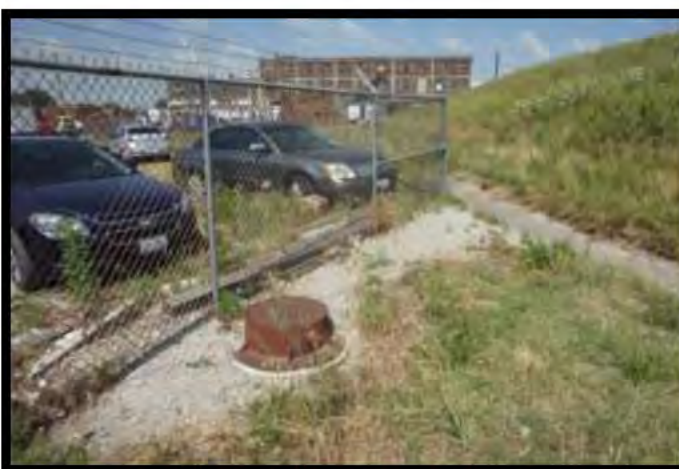
Photograph 54: Stormwater manhole near fence.

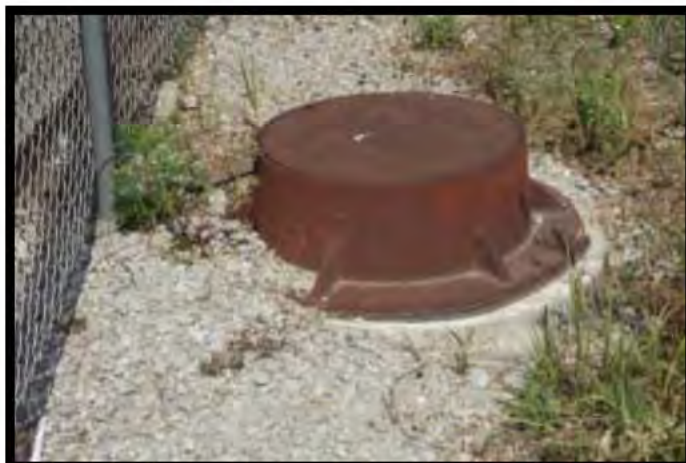
Photograph 55: Stormwater manhole.

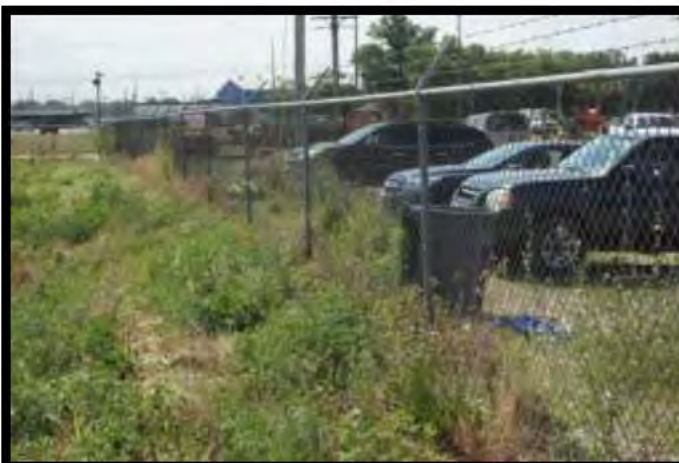
Photograph 56: Vegetation and fence near former Rich Oil facility (view toward State Street).

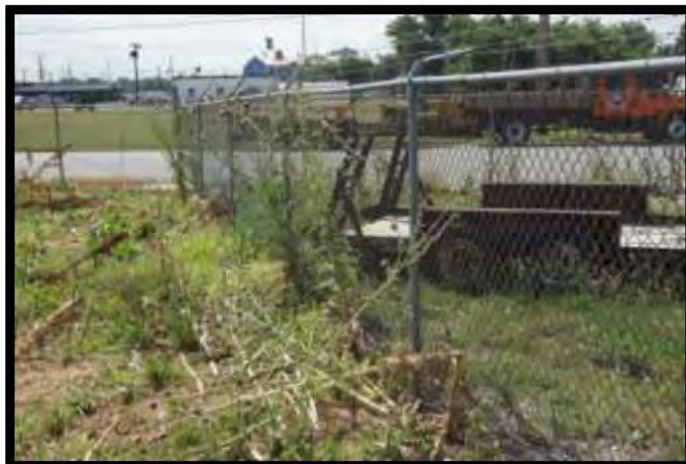
Photograph 57: Vegetation and fence near former Rich Oil facility (view toward State Street).

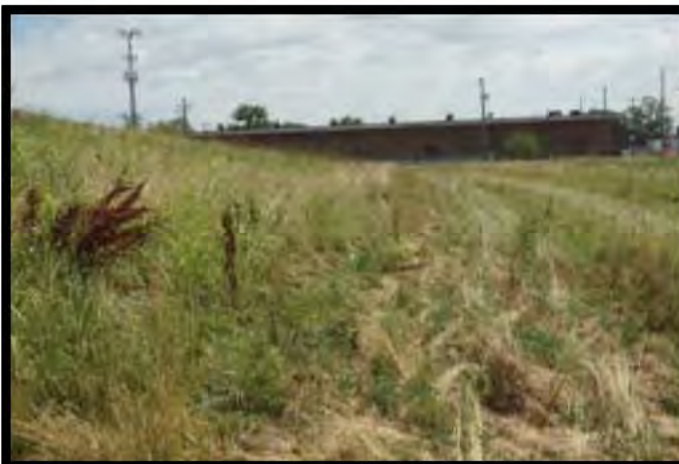
Photograph 58: Vegetation, eastern side of Taracorp pile cap.

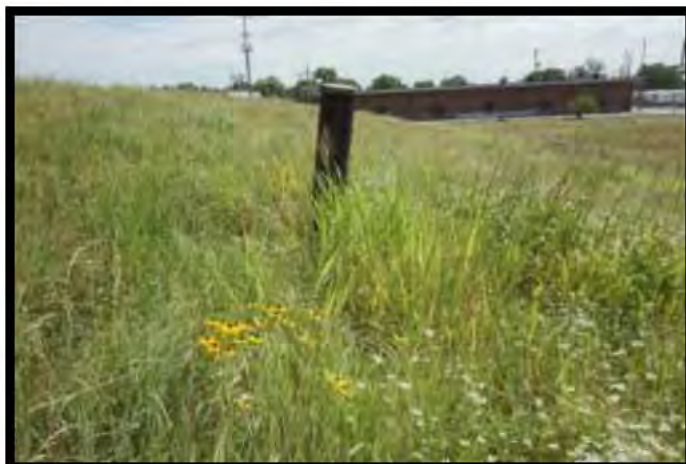
Photograph 59: Leachate riser pipe.

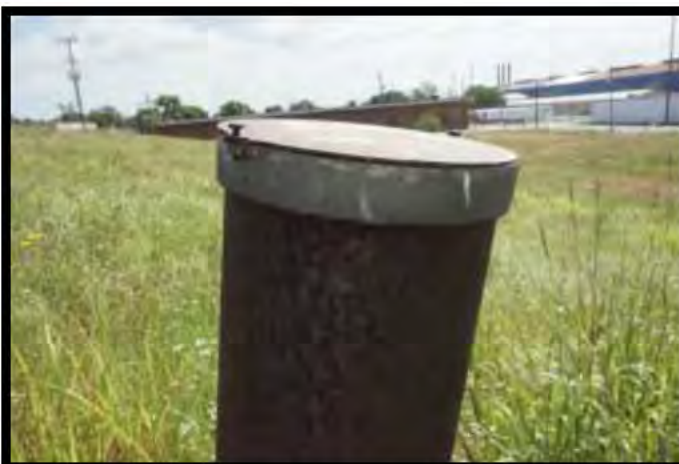
Photograph 60: Locked lid on leachate riser pipe (locked lid installed fall 2007).

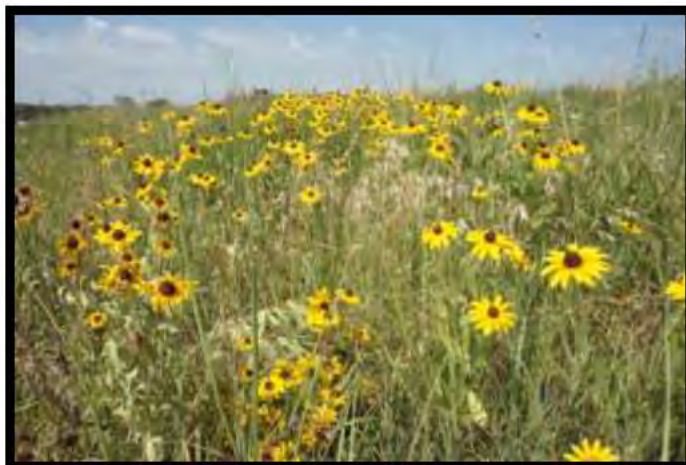
Photograph 61: Wildflowers and vegetation, top of Taracorp pile.

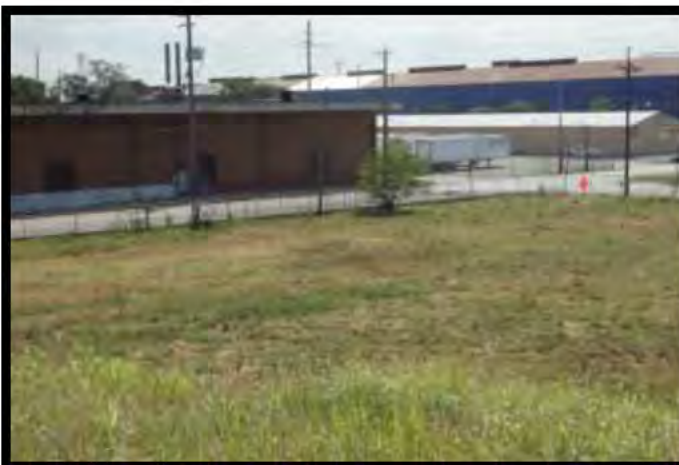
Photograph 62: Vegetation, former BV&G Truck Service area.

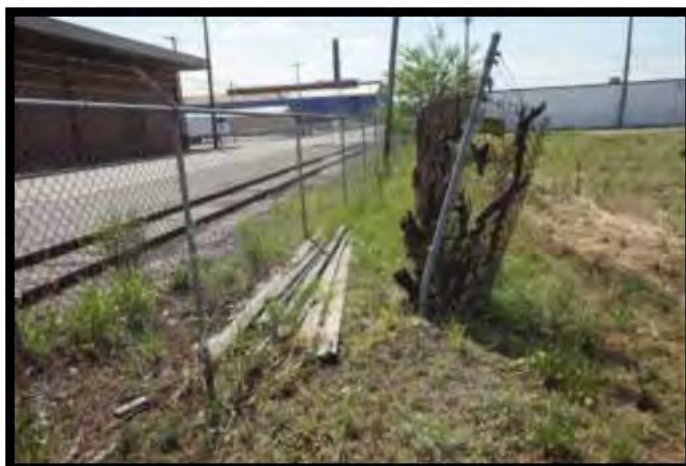
Photograph 63: Older and newer fence near former BV&G Truck Service buildings and along railroad tracks (view northeast).

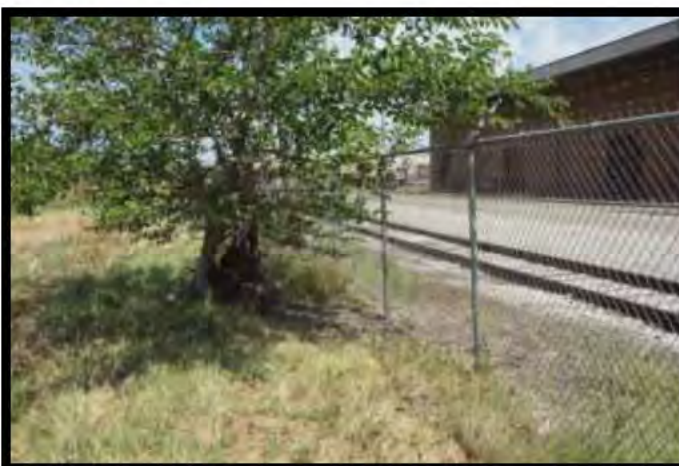
Photograph 64: Older and newer fence near former BV&G Truck Service buildings and along railroad tracks (view northwest).

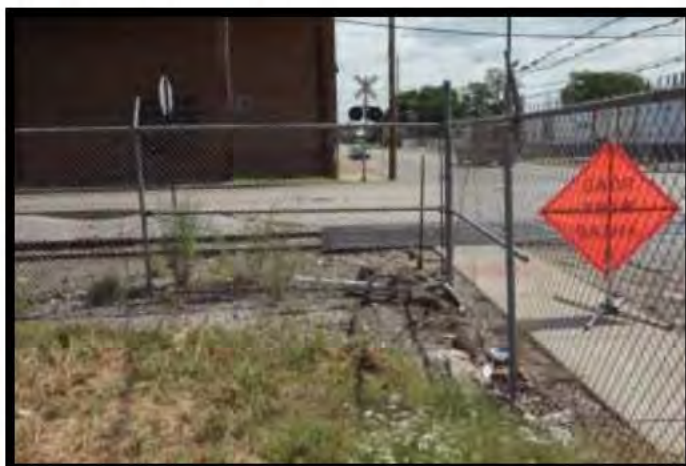
Photograph 65: Inside fence, corner of State Street and 16th Street.

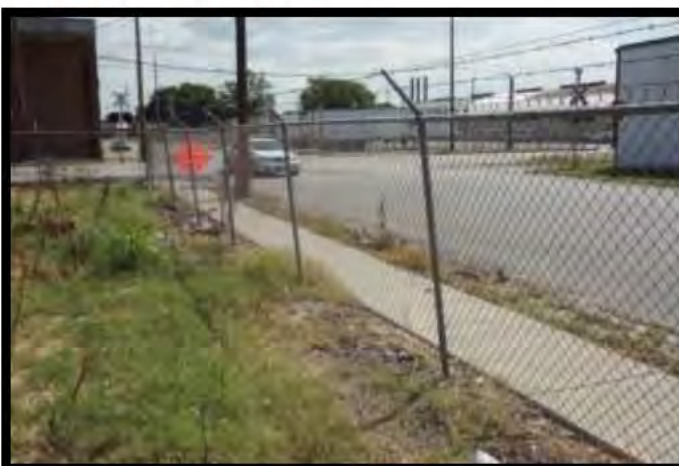
Photograph 66: Inside fence, corner of State Street and 16th Street.

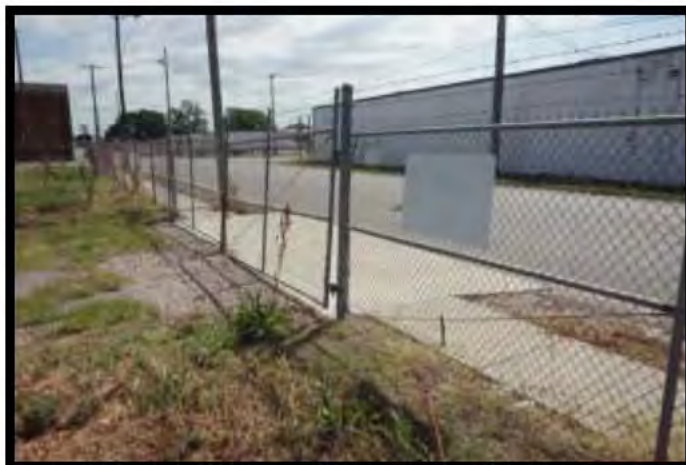
Photograph 67: Inside fence, gate along State Street.

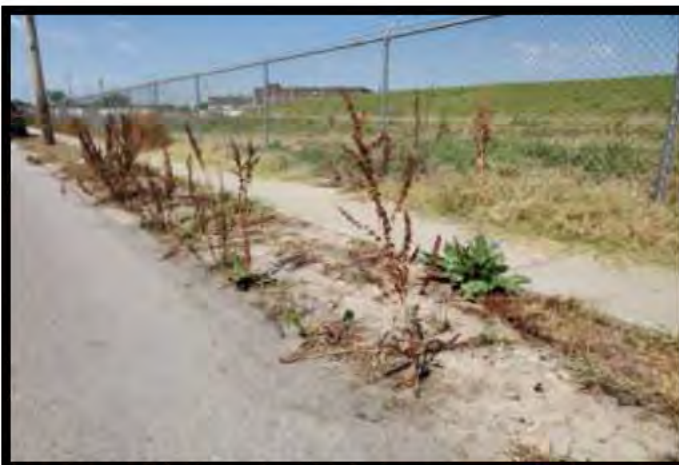
Photograph 68: Vegetation along State Street sidewalk.

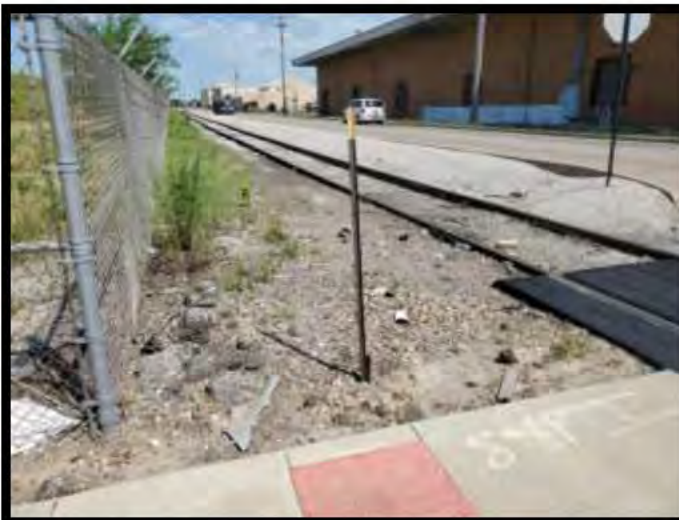
Photograph 72: End of State Street sidewalk at railroad tracks.

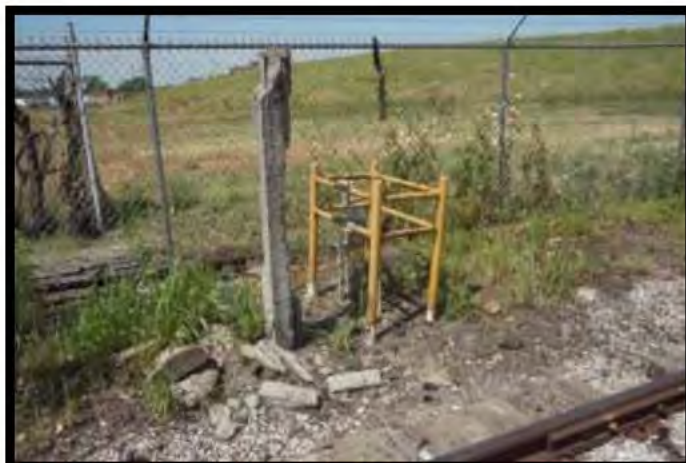
Photograph 73: Gas utilities along railroad tracks.

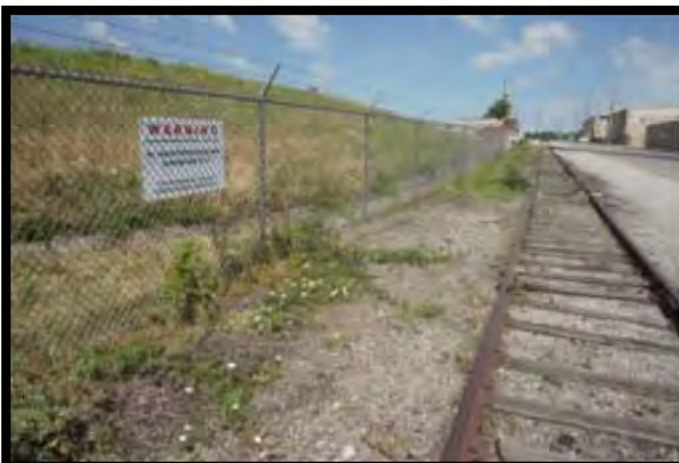
Photograph 74: Fence along railroad tracks and 16th Street.

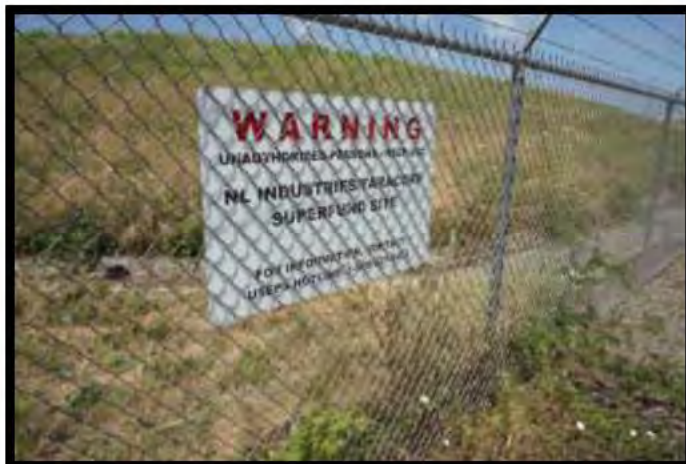
Photograph 75: Warning sign on fence along railroad tracks near 16th Street and Edison Avenue.

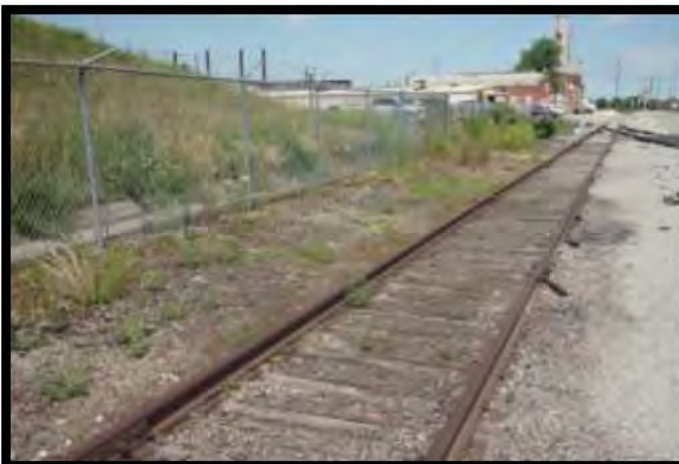
Photograph 76: Fence along railroad tracks and 16th Street.

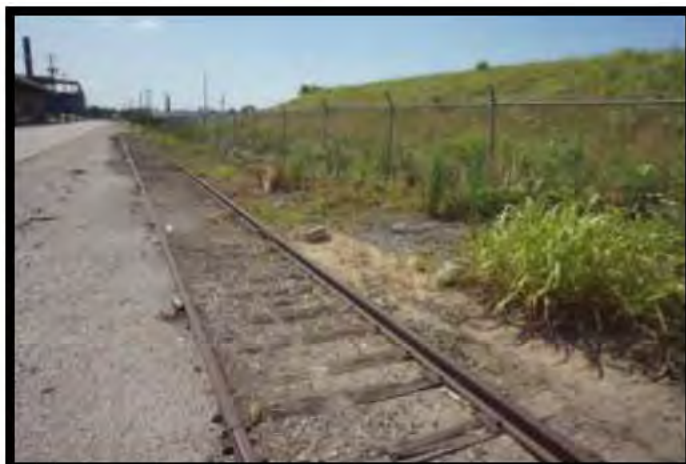
Photograph 77: Fence and vegetation along railroad tracks and 16th Street.

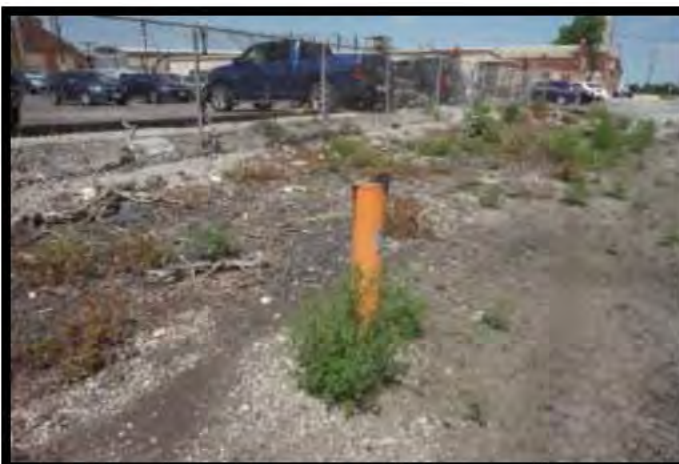
Photograph 78: Monitoring well MW-101.

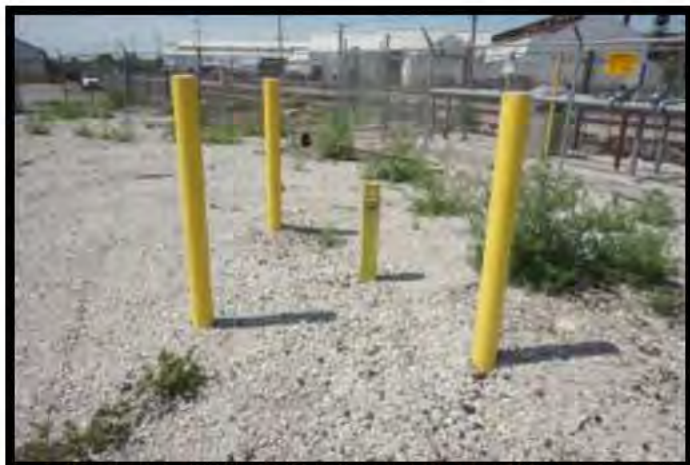
Photograph 79: Recently constructed bollards around monitoring well MW-105D.

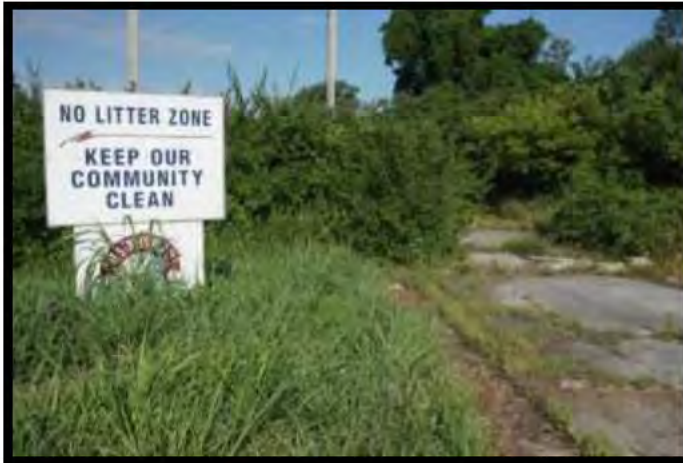
Photograph 1: Schaeffer Road property, entrance.

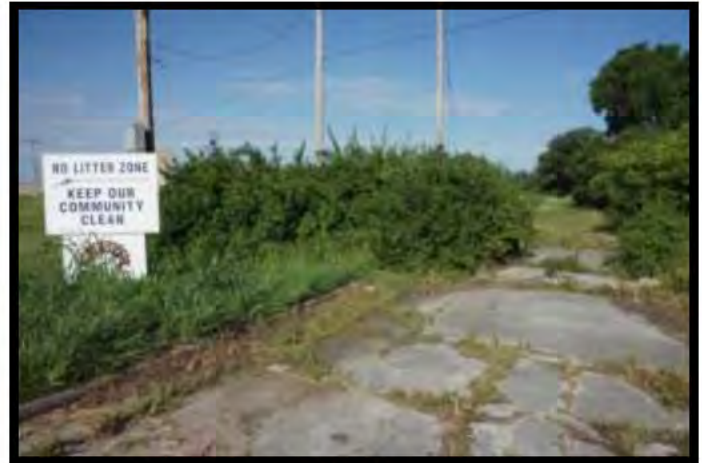
Photograph 2: Schaeffer Road property, entrance.

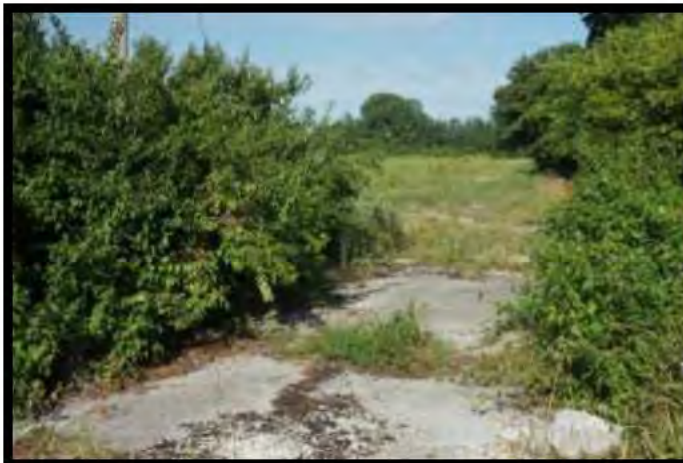
Photograph 3: Schaeffer Road property, entrance.

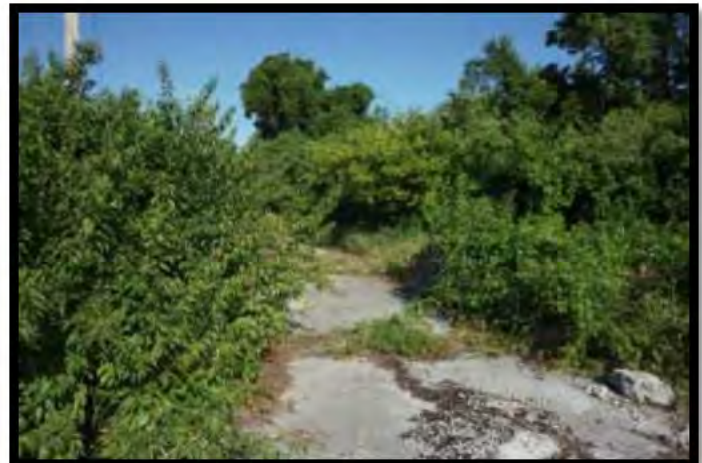
Photograph 4: Schaeffer Road property, entrance.

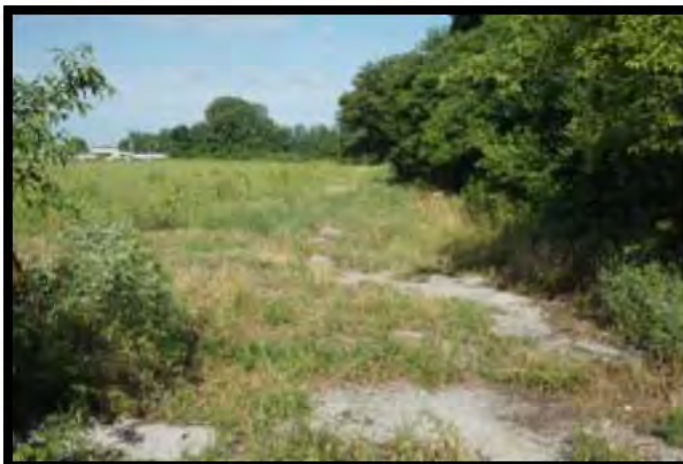
Photograph 5: Schaeffer Road property, entrance.

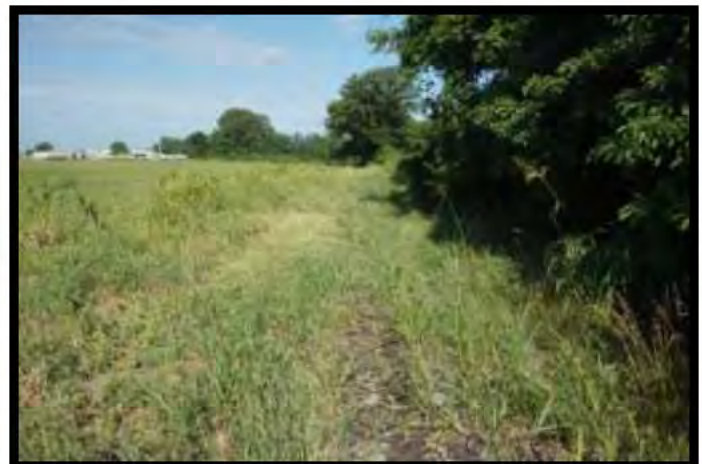
Photograph 6: Schaeffer Road property, roadway.

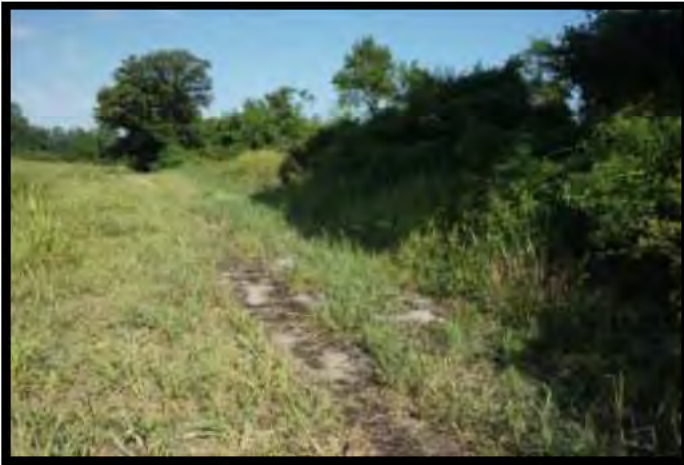
Photograph 7: Schaeffer Road property, roadway.

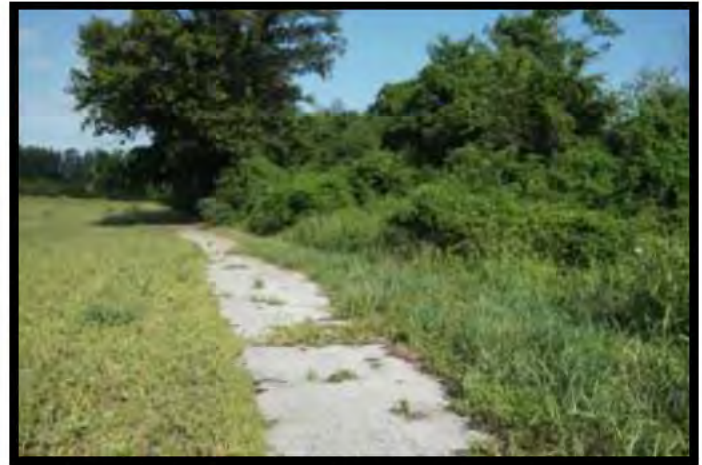
Photograph 8: Schaeffer Road property, roadway.

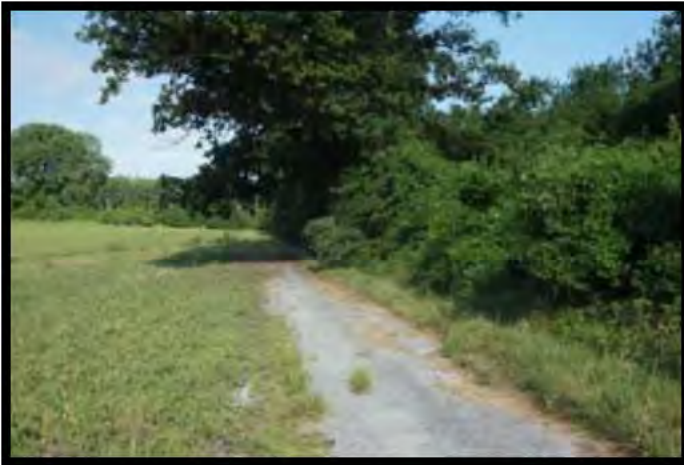
Photograph 9: Schaeffer Road property, roadway.

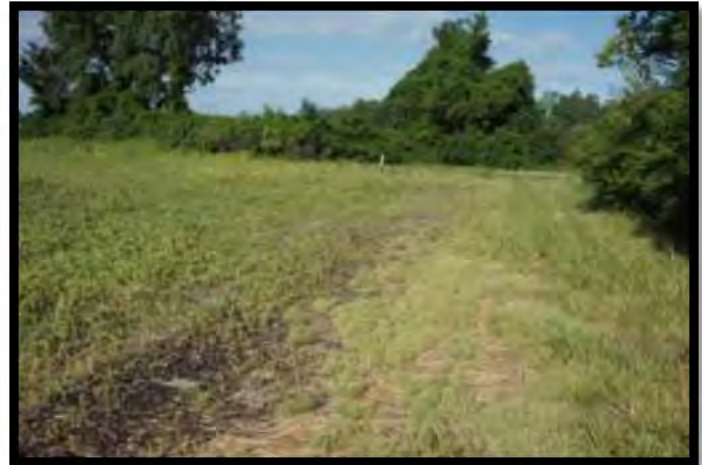
Photograph 10: Schaeffer Road property, roadway.

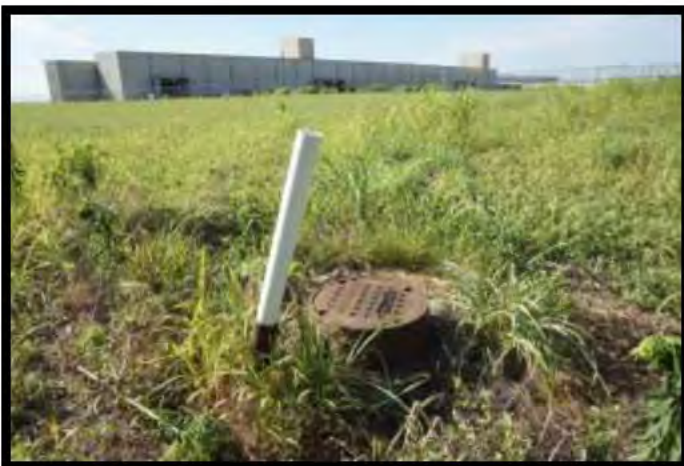
Photograph 11: Schaeffer Road property, sanitary sewer manhole.

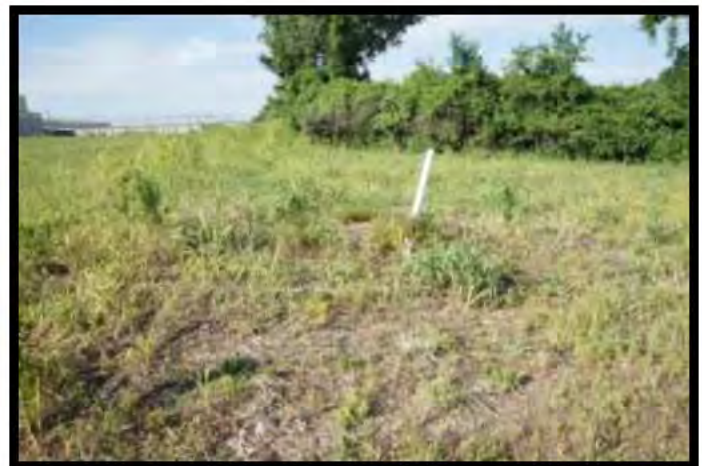
Photograph 12: Schaeffer Road property, sanitary sewer manhole.

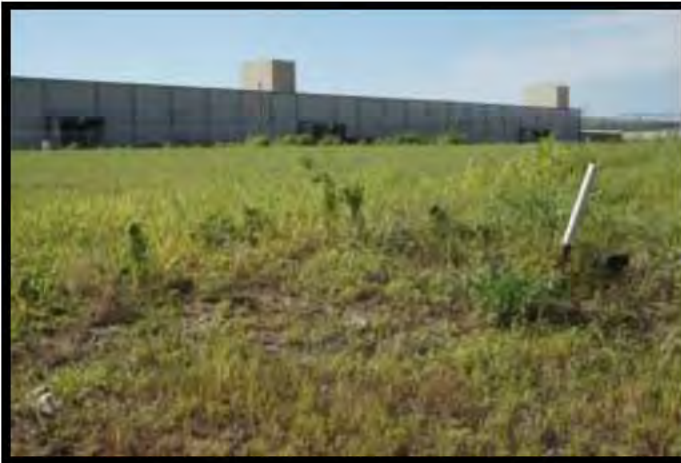
Photograph 13: Schaeffer Road property, field near sanitary sewer manhole.

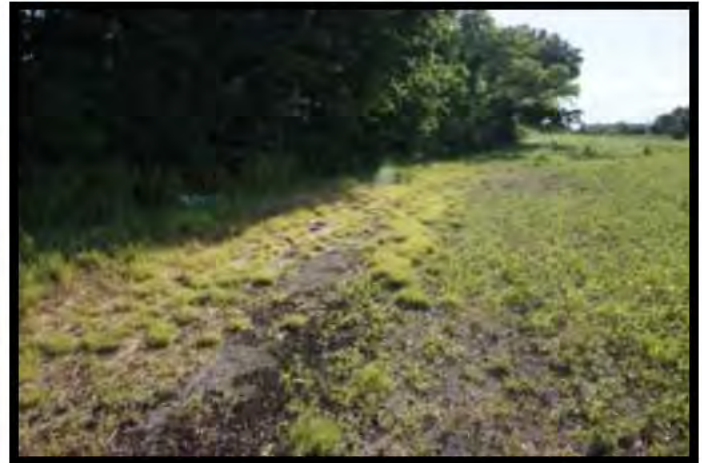
Photograph 14: Schaeffer Road property, road.

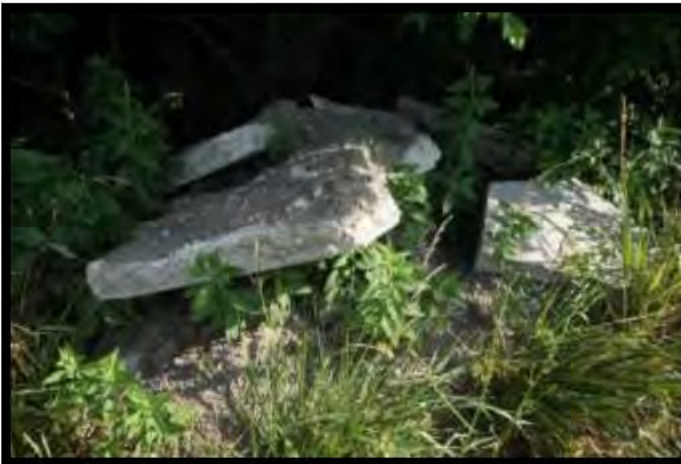
Photograph 15: Schaeffer Road property, concrete debris in vegetated area along road.

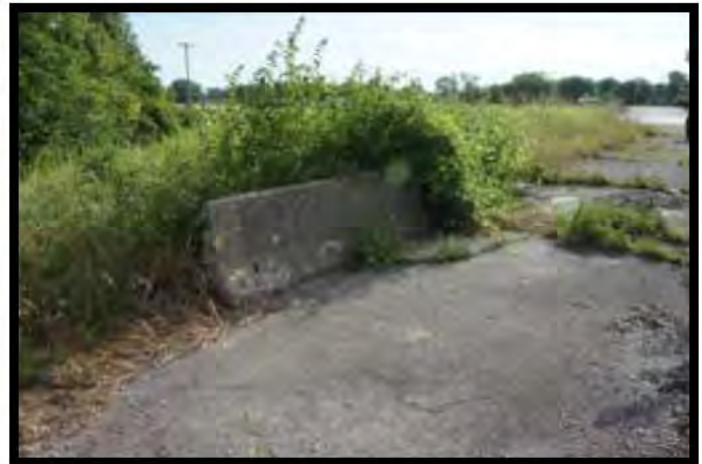
Photograph 16: Schaeffer Road property, concrete barrier at entrance.

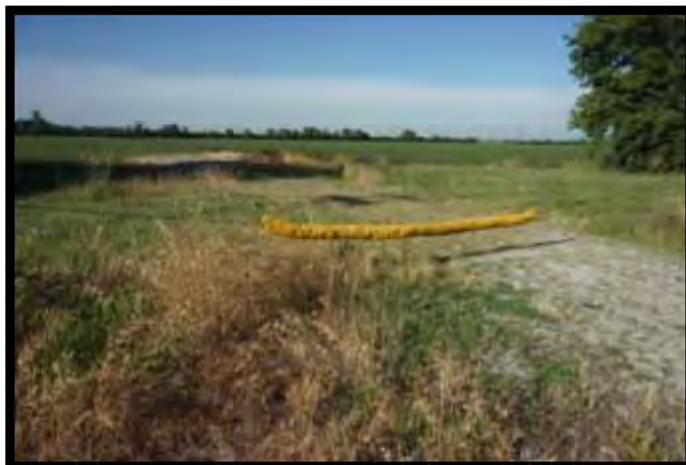
Photograph 1: Sand Road property (view from entrance).

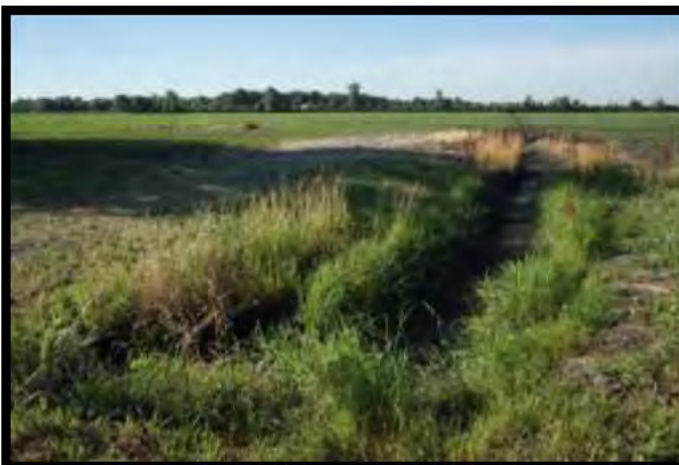
Photograph 2: Sand Road property, stormwater drainage ditch.

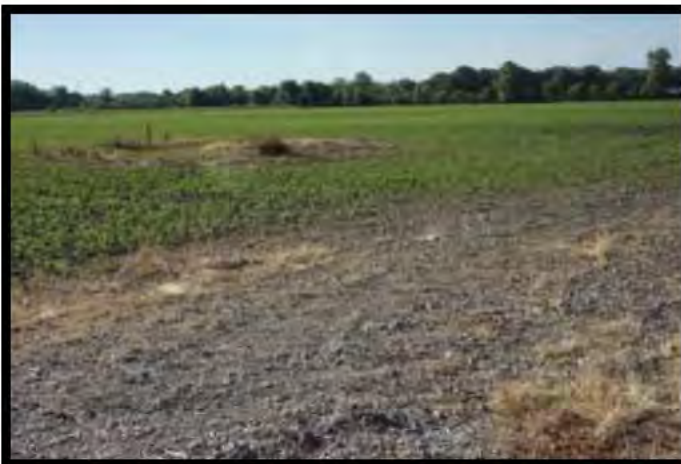
Photograph 11: Sand Road property, gravel access road (foreground), concrete foundation (background).

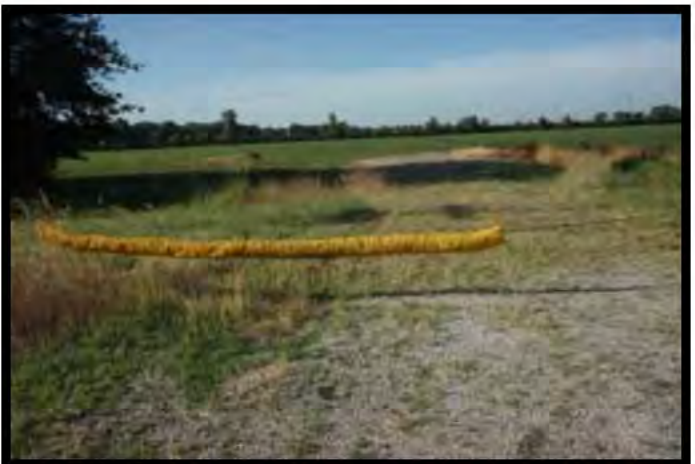
Photograph 12: Sand Road property, entrance.

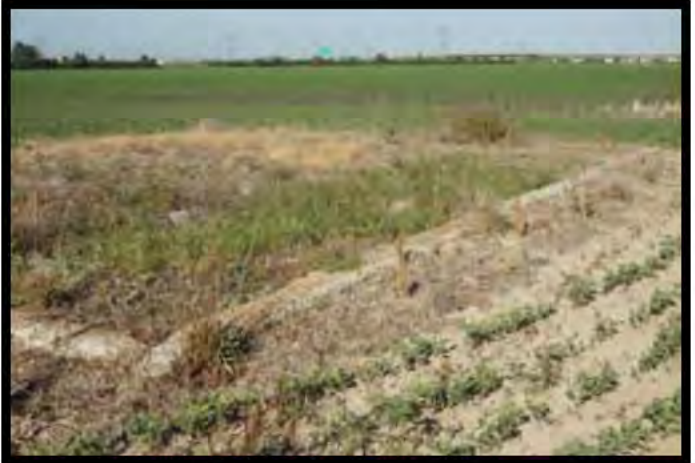
Photograph 14: Sand Road property, concrete foundation.
